# G235 & G236 EGT Sensor Repair/Regeneration Manual

( Ver.1.1 based on the 2.7BiT A6 with GPL )

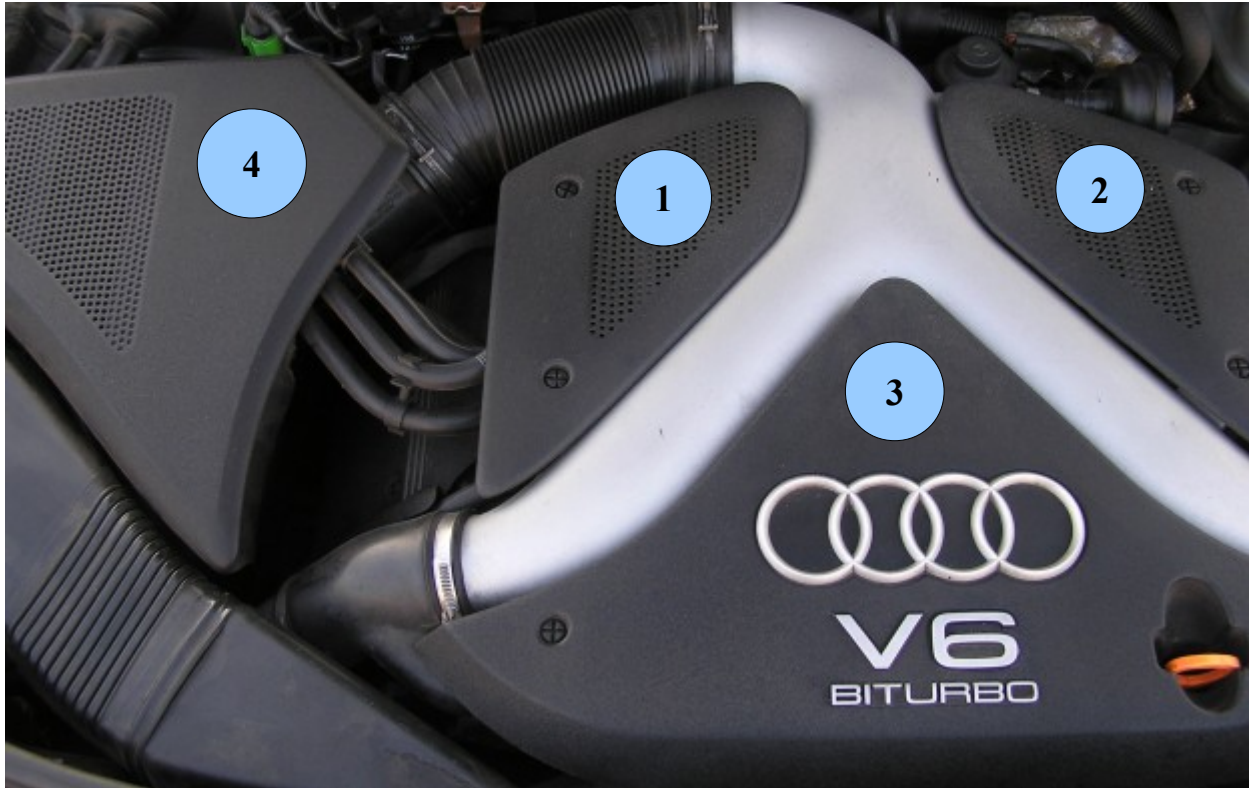
1. Remove the engine (1,2,3) and the air filter (4) beauty covers

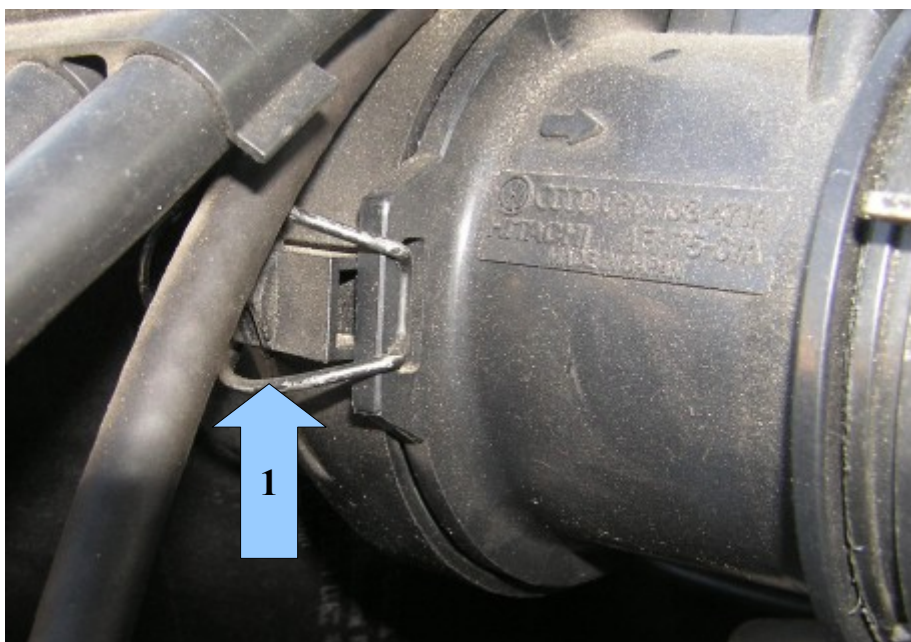
2. Disconnect MAF housing from the air box filter (two clips - one marked No.1 on the picture, the other on the opposite side of MAF. Additionally, you can remove MAF. When removing MAF be careful of the rubber ring gasket in the MAF housing flange.

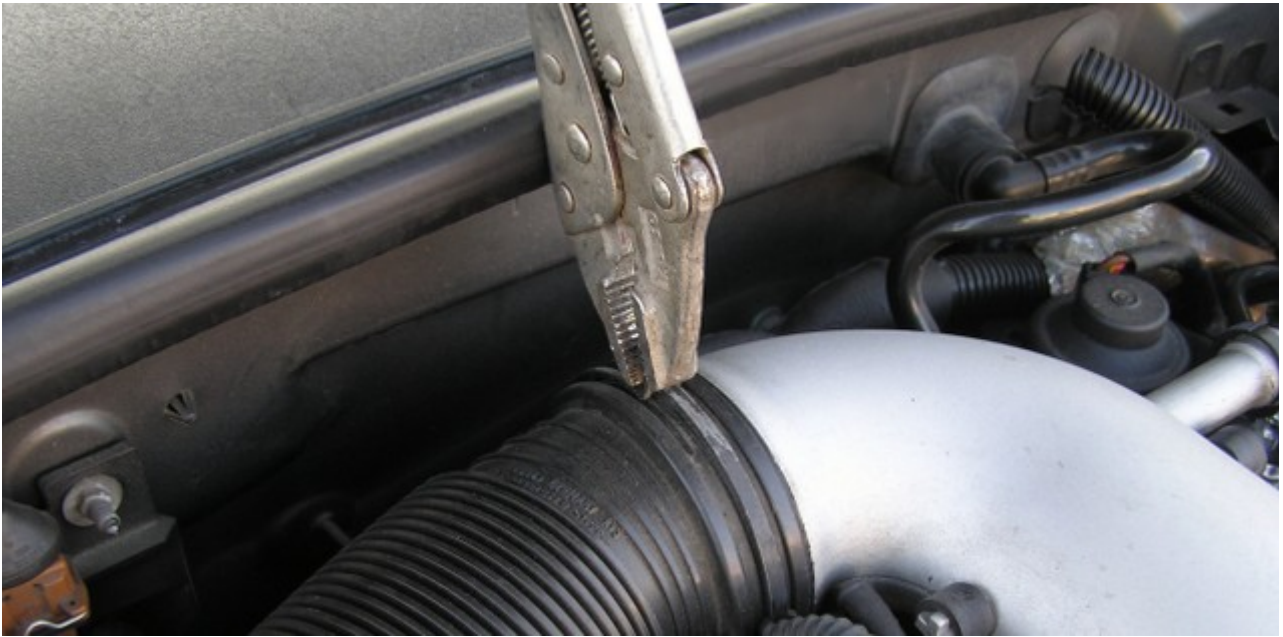
3. Remove the pipe connecting MAF with „Y” air distributor.

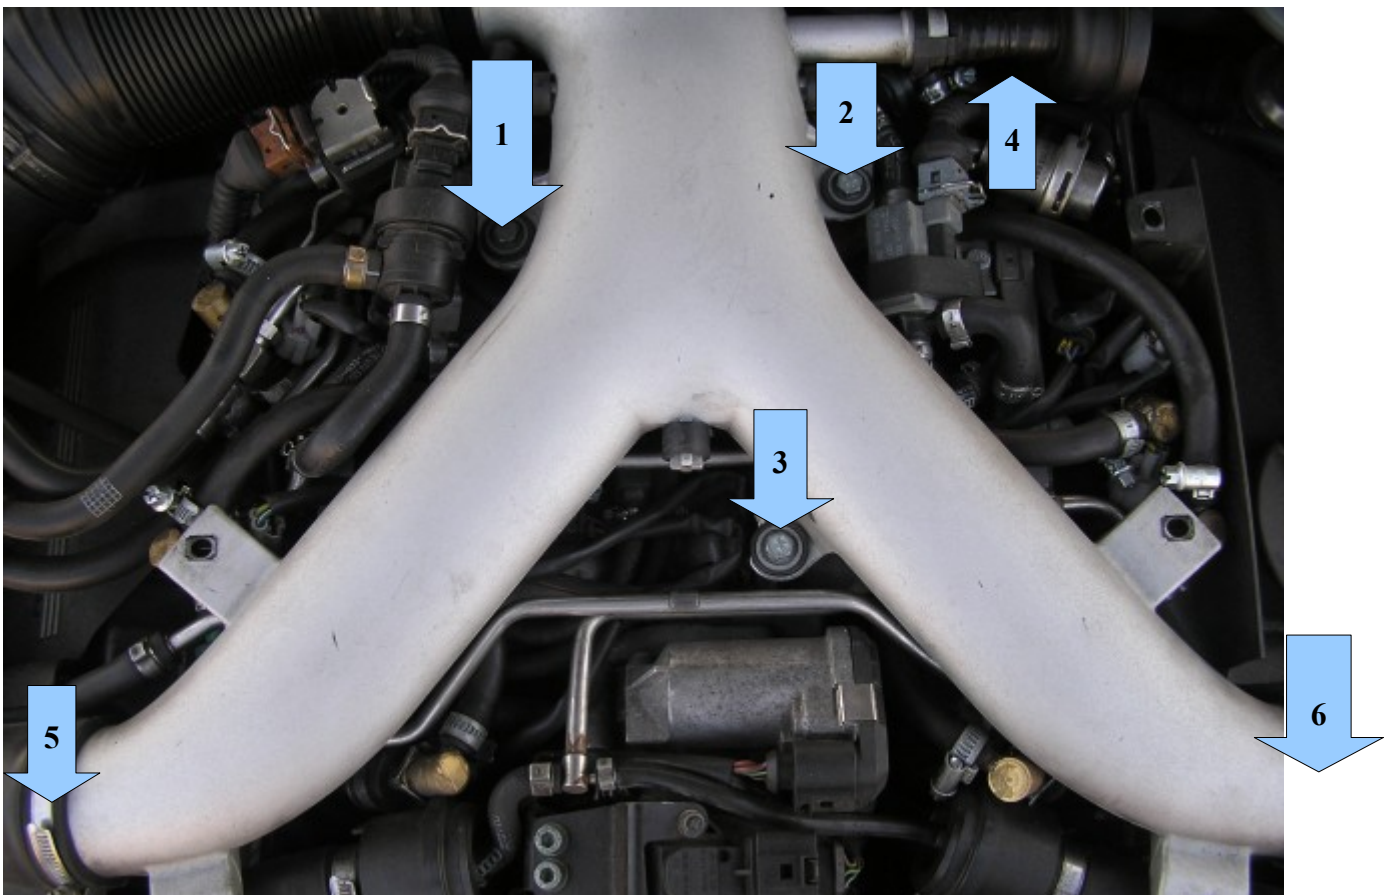
4. Remove the „Y” air distributor. To do this, unscrew three M6 screws (1, 2, 3), disconnect the pressure limiting valve (4) and release two clamps located near DV's (5 and 6). Then remove the „Y” air distributor. After this operation, two EGT's are easily accessible (in AJK, AGB engines EGT's are placed symmetricly to the longitude motor axis, in ARE, BES both EGT's are on the right side of the engine in the same place)

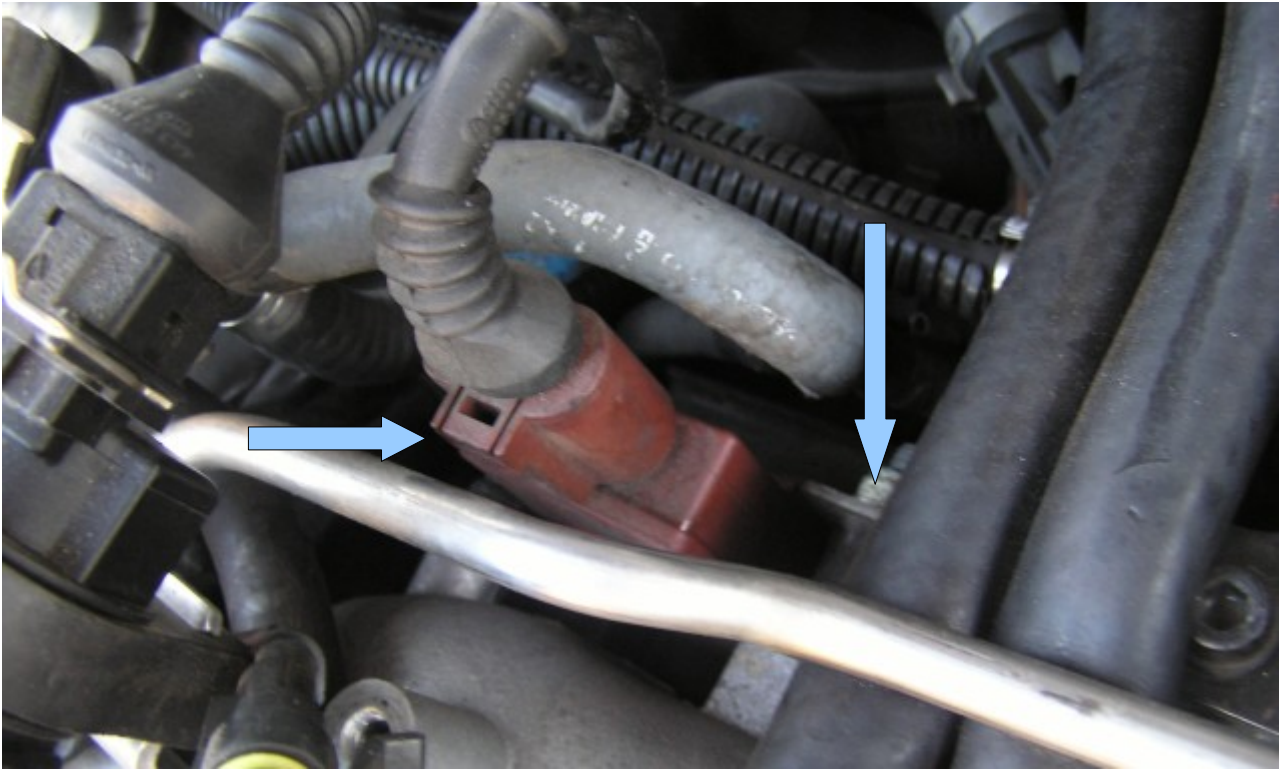
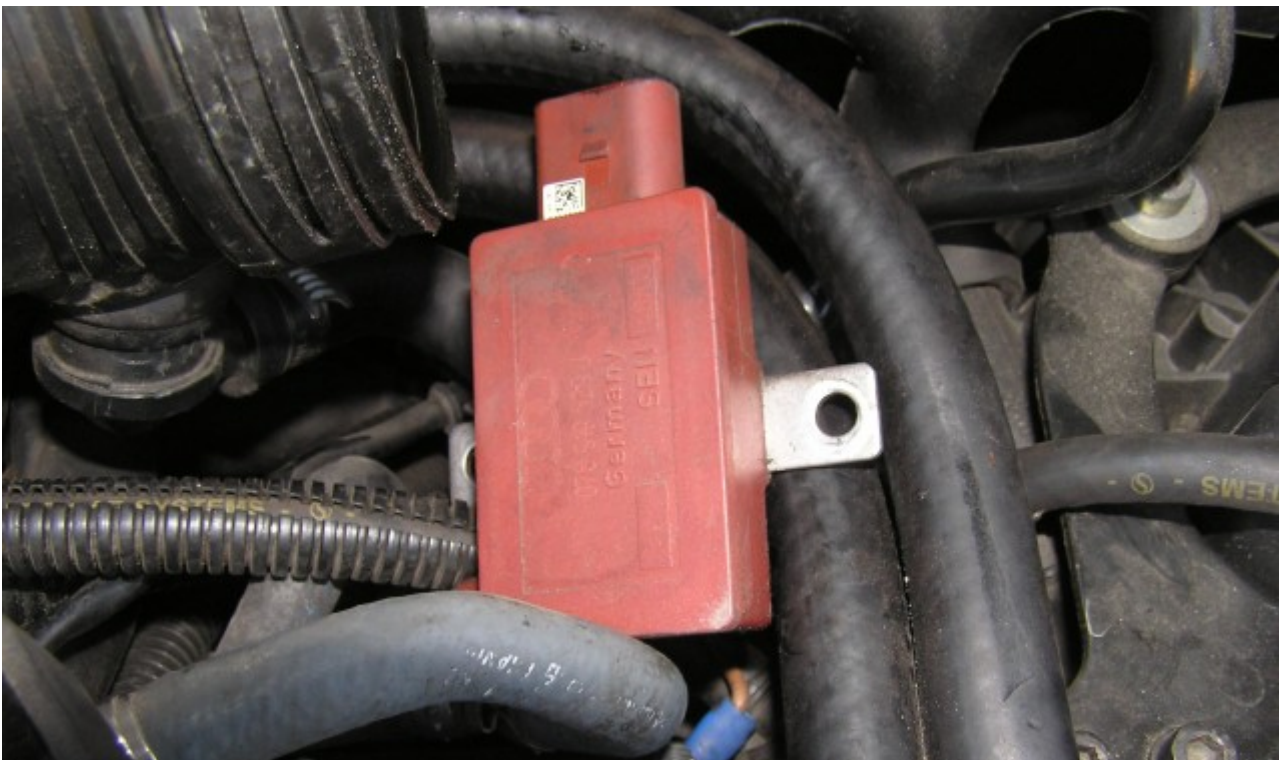
5. Unscrew EGT electronics (2 nuts M6).

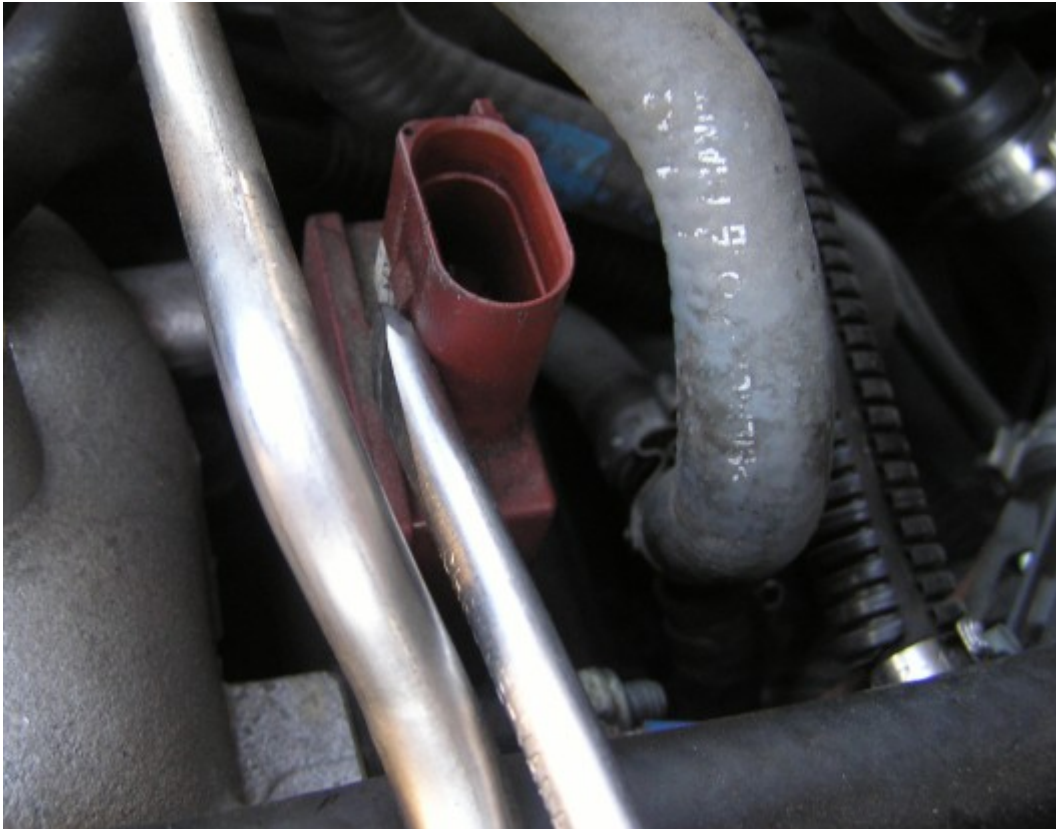
6. Open EGT electronic housing. There is no uniform recipe to do this. Sensors could be levered near connector, but depending on how it is glued by the producer, sometimes it's easier, sometimes harder to open it.

Steps 5 and 6 can be replaced - it even seems, that it may be even easier to open electronic housing, as it is still bolted to the intake manifold.

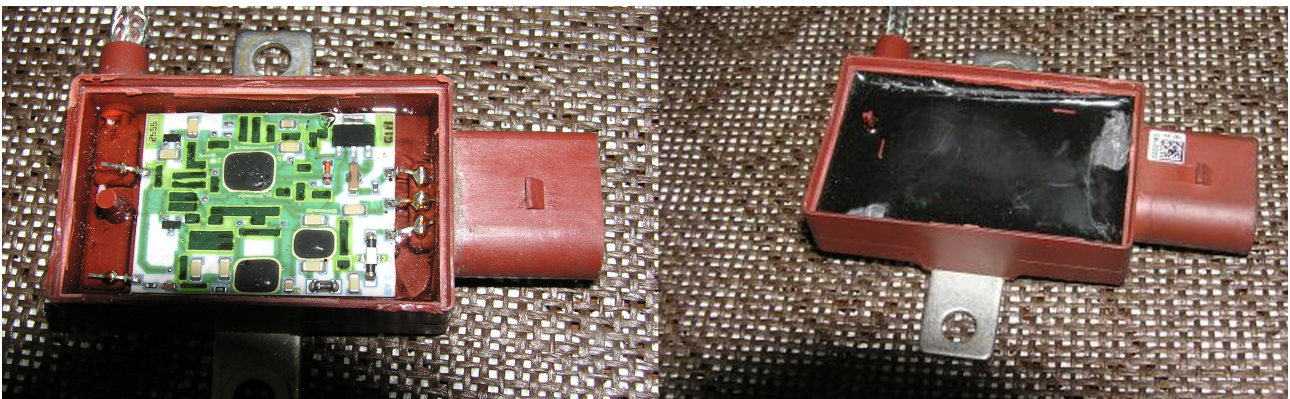
7. Once the EGT electronic housing is opened, the old electronic should be removed. Depend on version of the EGT sensor, electronics could be protected by various substances. Once again, there is no uniform recipe for the removal - this step should be done according to yours own invention. The easiest way is to remove transparent silicone (photo below - left), the hardest covering substance is black rubber (photo below - right). When removing the protective substance, be careful not to damage the electrical thermpcouple and external connector connections.

8. After removing the protective substances desolder (or cut), old electronics and disassemble it. Be careful not to damage electrical connections.

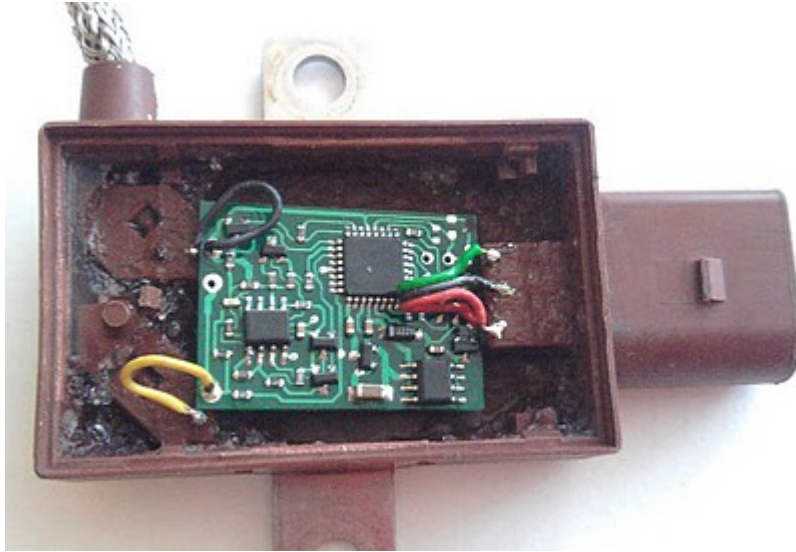
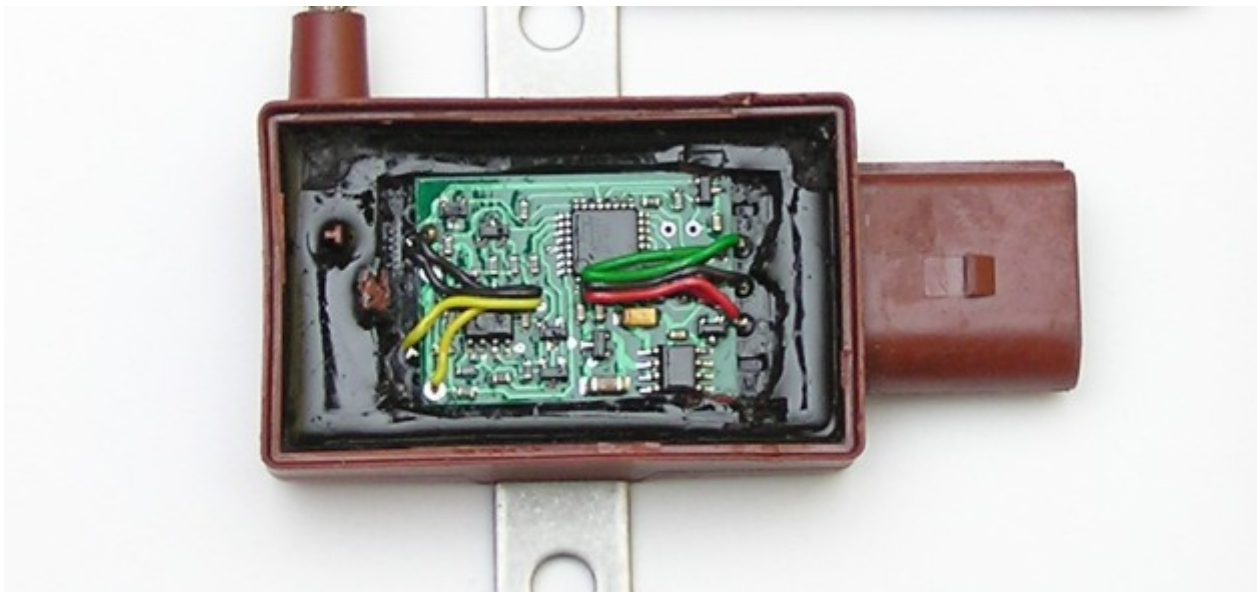
9. Solder new electronics as it is shown in the pictures below. Wires should fit on the pins/solder contacts.

It is recommended to fix electronic circuit by double sided tape. After soldering, check if soldering did not cause short circuits, especially on the EGT connector side. Optionally, you can protect soldering places by any kind of protective coating. The circuit is already protected.

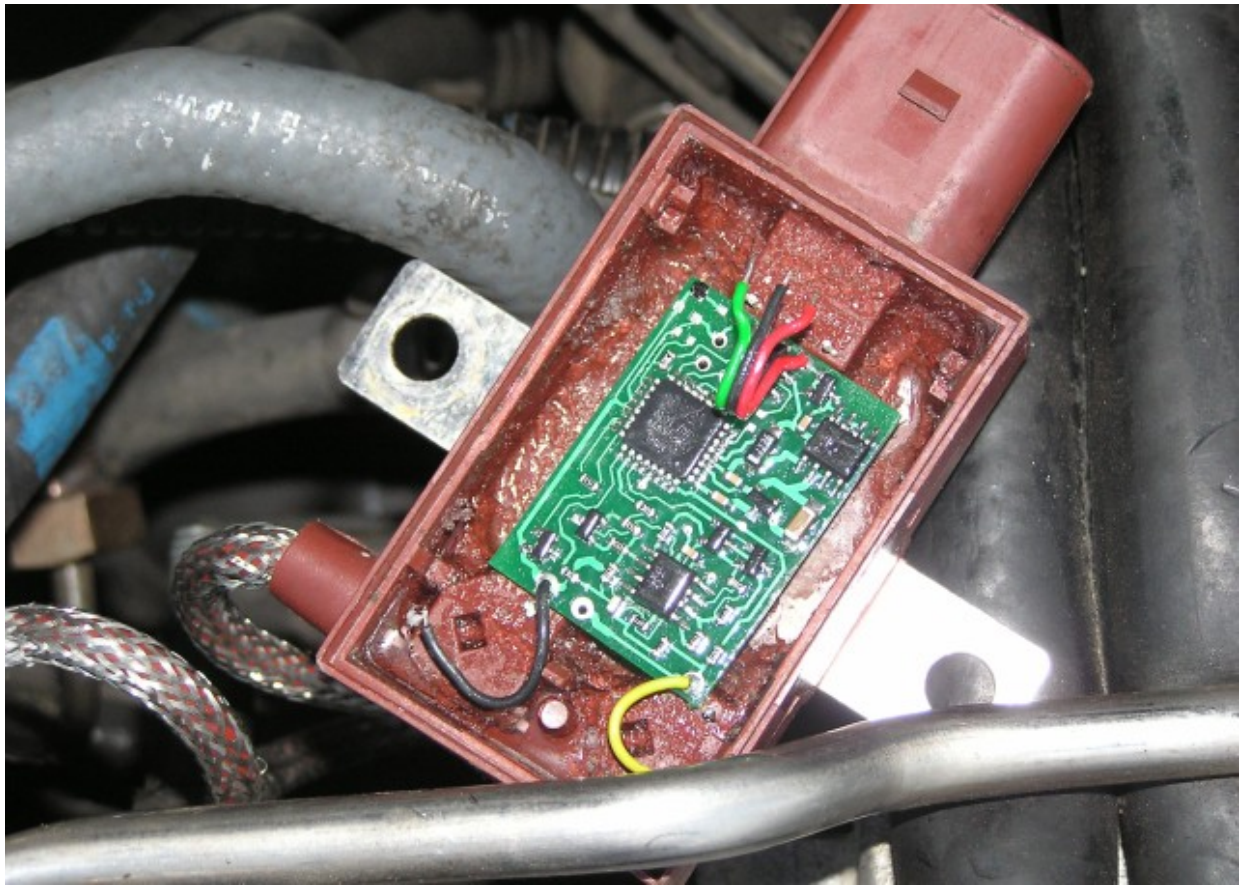
**Note:** Steps 7, 8 and 9 shall be performed without removing the sensor from the car. The pictures were captured on the disassembled sensor only for description clarity.

10. Stick the EGT sensor "lid".
11. Put things together in reverse order.
12. Enjoy a well done job :-)
